Wildfire Hardened and Energy Efficient Building Assemblies –

Chad Gretzner - Research Engineer & NFPA RWRPP

Funded by Energy Codes and Standards Southern California Edison 2025

San Bernardino Regional Emergency Training Center Burn Test January 30th, 2024

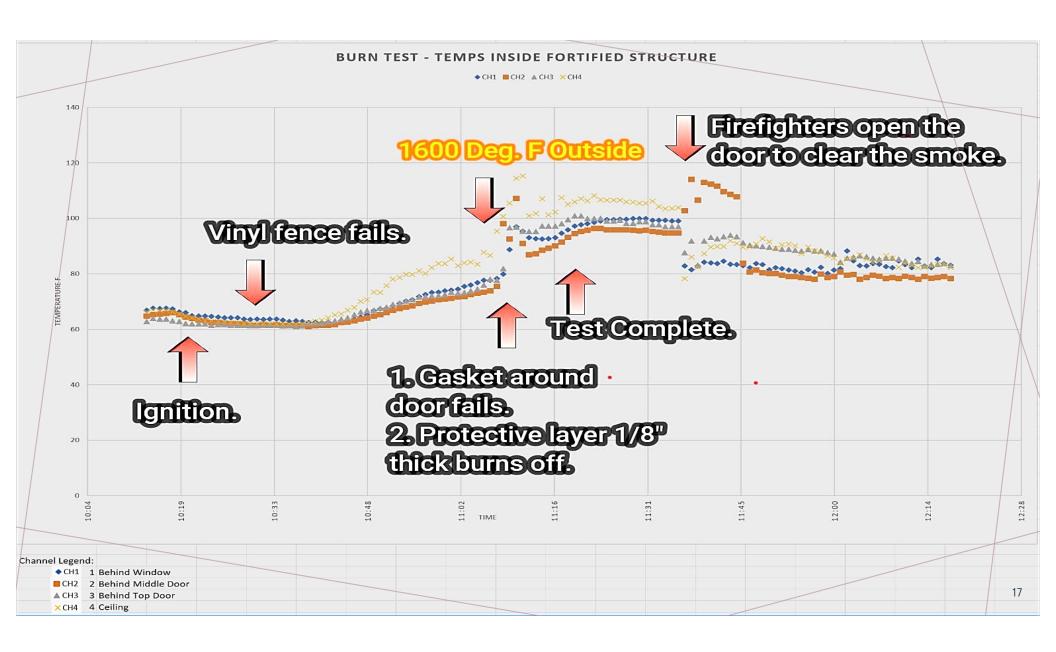
Vinyl fence melts and does not sustain flame.

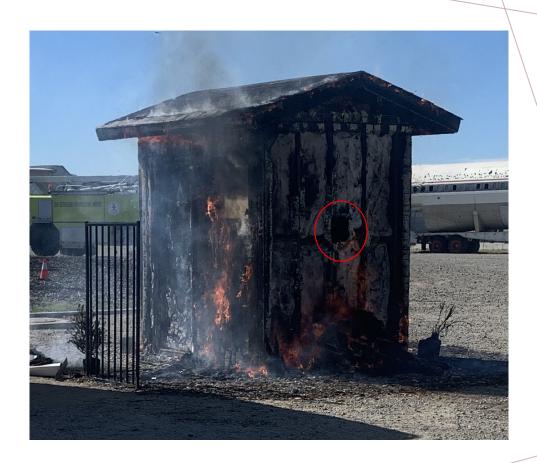
FR-Paint & Coating

FR-paint provided 15 minutes of protection.

Neither are approved in California building codes.

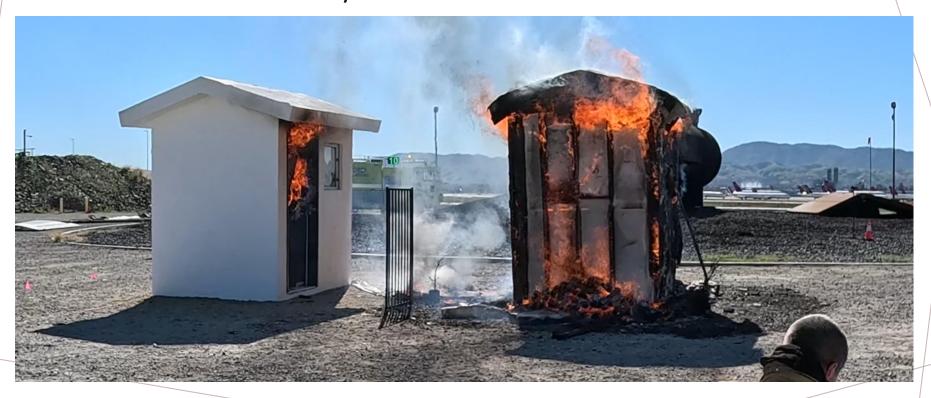
Forensic Study

1/8" Layer on the 60min. FR-Door Contributes to Direct-Flame Exposure to the Closed Eave.

Observations

- Eaves trap heat.
- Extremely vulnerable to ignition.
- Relatively easy to enclose with non-combustible materials.

Recommendations

- If attics are vented, use ember and fire-rated vents with 1/16"-1/8" openings. Options may include:
 - Stainless steel wire (looks like steel wool).
 - Intumescent firestop materials; Expands when heated which closes the screened openings preventing ember and direct flame exposure.
 - Replaceable cartridge design.
 - Metal louvers over the screen mesh prevents the screen mesh being painted over.

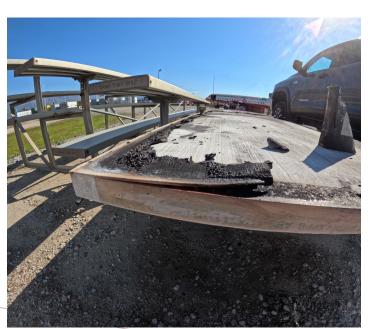
60-Minute Fire Rated Door

1/8-inch layer burned off.

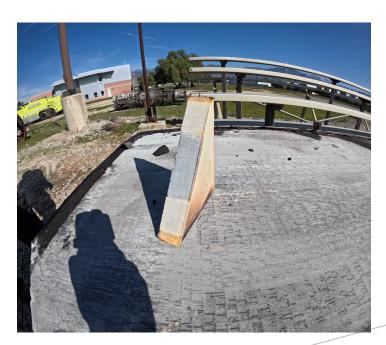
Non-Combustible Core

Heat Transfer at the Hinges

Concentrated heat at the door hinges.

Fiber cement & drywall withstood heat transfer.

Wood stud was scorched at steel hinge.

Recommendations

- Ensure the steel door frame is installed over noncombustible materials such as drywall or fiber cement board.
- Use thermal breaks to prevent heat transfer.
- Caulk any gaps with fire rated caulking or intumescent materials in through-hole penetrations.

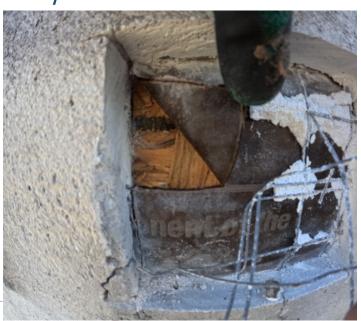
Non-Combustible Siding/Roof: U-Stucco

No damage to wood sheathing or underlayment

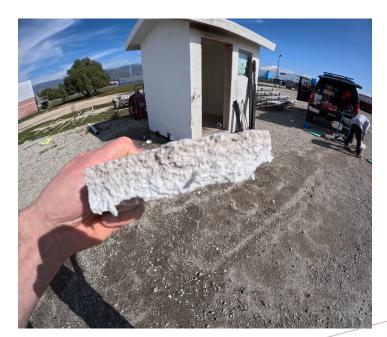
Heat did not transfer through U-Stucco

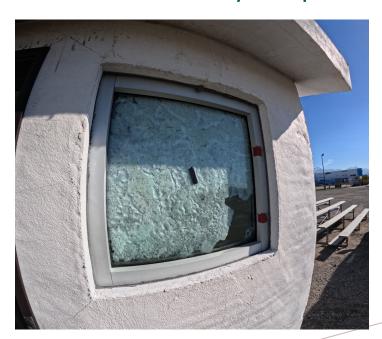
SAFTIFIRST 60min. Fire Rated Window

Intumescent Interlayer Expands

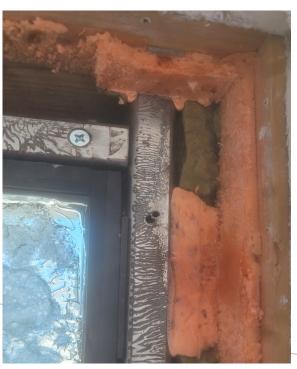
SAFTIFIRST 60min. Fire Rated Window

Appears the gypsum pack plastic coating heated up enough to stick to the steel tubing

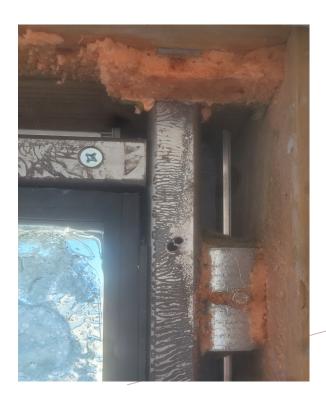
Wood framing undamaged
