RECESSED LED DOWNLIGHTS

ET11SCE3010 Report

*Design & Engineering Services
Customer Service Business Unit
Southern California Edison*

November 2012

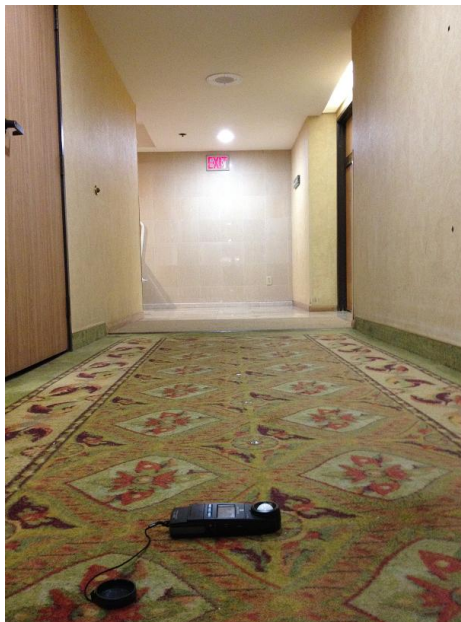
FIGURE 1. LIGHT METER & MEASURING POINTS

The FC readings were measured at four to nine different points near and around the lights. Each point was marked with a piece of tape to take measurements at the same spot after the LEDs were installed. Because the lights were located inside rooms or hallways without windows, the sun did not interfere with the readings at most sites. Residential homes required waiting until dark to take the measurements. The readings from the light meter were recorded.

Figure 1 shows the light meter and measurement points at a customer site.

A Konica Minolta T-10 Illuminance Meter was used to measure the FCs at each installation site. This meter is designed to measure the brightness and quality of a light source striking a specific location.

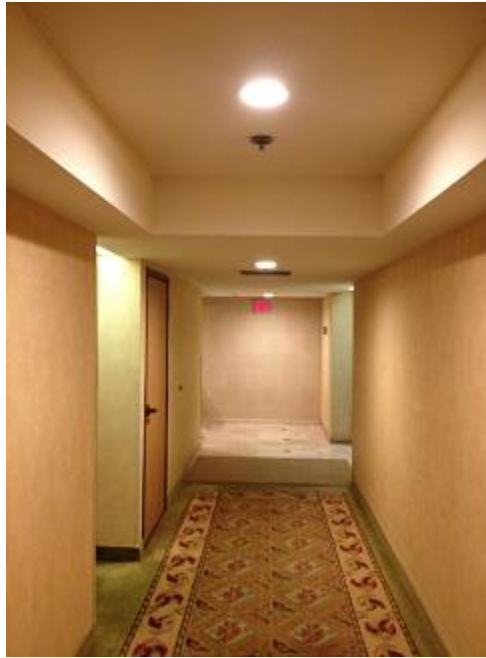
FIGURE 2. HOTEL #1 LED

Figure 2 shows Hotel #1 with LED downlights retrofitted into an existing can.

The Hotel #1 customer showed a great deal of interest in participating in this project because the site's downlights operate 24 hours per day. The customer had three floors of 6" recessed downlights that operated a 15-Watt (W) 700 lumen Reflector CFL (RCFL). Each floor had 85 downlights in the hallways leading to the guest rooms and the customer chose to install the lights on one floor. The RCFLs were replaced with 10.5W, 650-lumen LED downlights.

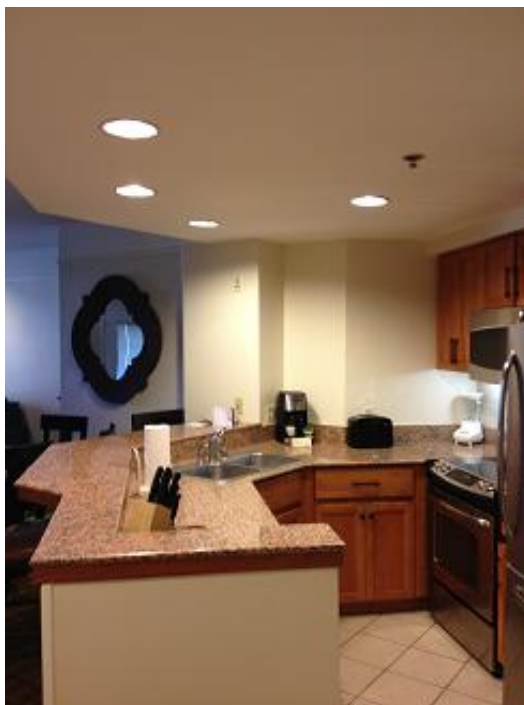
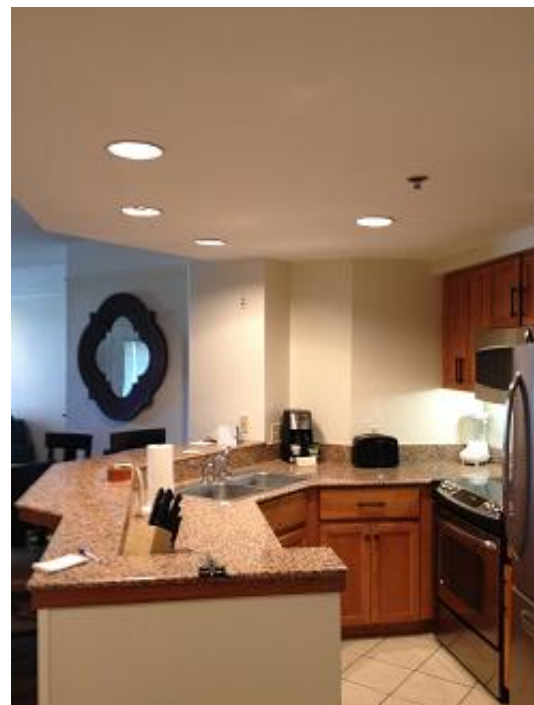
FIGURE 3. TIMESHARE CFL & LED

The 26W CFL outputs more light than is needed. A typical light bulb used in recessed cans is a 15W CFL. Figure 3 shows the installation of CFL and LED screw-in lamps in a downlight application. The pictures are not representative of the light intensity because the camera auto-exposes the scene to maintain the same brightness.

CFL

LED

At the time of the visit to the timeshare, rooms were currently being refreshed with new paint, lights, etc. The existing lighting was a 15W, 950-lumen spiral CFL. Given the fixture efficiency of approximately 50%, an 8W, 486-lumen LED screw-in directional lamp was chosen to replace the CFL. On the day of the installation, a vacant room was offered for testing but did not have the same wattage CFLs, as these rooms had not been refreshed. The baseline changed from a 15W to a 26W CFL, hence the large variation in the light measurements, as shown on Table 3. The measurement points at this site were along the countertop in four different points spread out evenly and one point at a small table nearby.

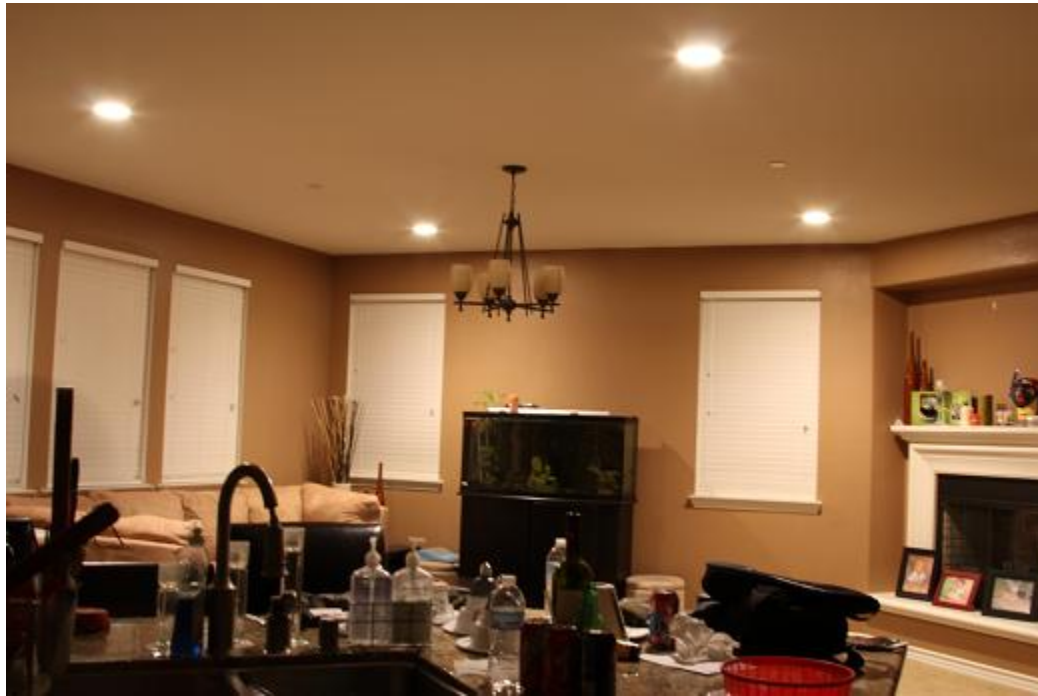
FIGURE 4. RESIDENTIAL CUSTOMER #1 LED RETROFIT

Residential customer #1, like many potential residential customers, could benefit by switching from 60W incandescent reflector lamps to LEDs. The kitchen had hard-wired CFLs installed due to building codes. The living room, dining room, and office all had 60W incandescent lamps on dimmers, which can be replaced. Ten total downlights were replaced at the house, with four LED downlights retrofitted into the living room, as shown in Figure 4.

Existing lights were 60W incandescent 650-lumen lamps, and were replaced with a 9.5W, 575-lumen LED downlight. Table 3 shows significant improvement in all three rooms. With more light than before, the home saved about 85% in energy use and had the potential to save more by using the existing dimmers. The measurement points in all the rooms were taken at the work plane; coffee table in the living room, desk in the office, and dining table in the dining room.

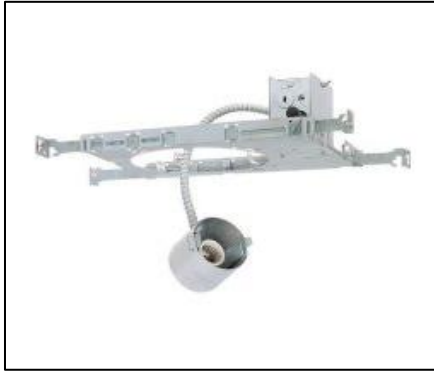
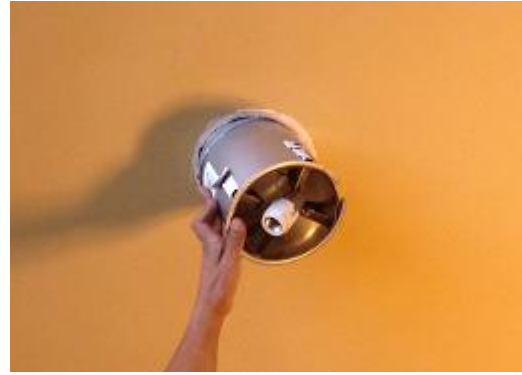
**Retrofit Can****FIGURE 5. LED RETROFIT KIT**

Existing pin-CFLs in the lobby were in open-style housings, as shown in Figure 5, which required retrofit cans to install the LED downlights. The open-style housing was molded into the dry wall and measured 6" at the opening. A 6" retrofit can measured at 6.125" and did not fit into the housing. Although the existing housing could have been cut, modification to the existing housing was avoided due to cost and disruption to the customers for a project that only required a short test.

**Open Style Housing**

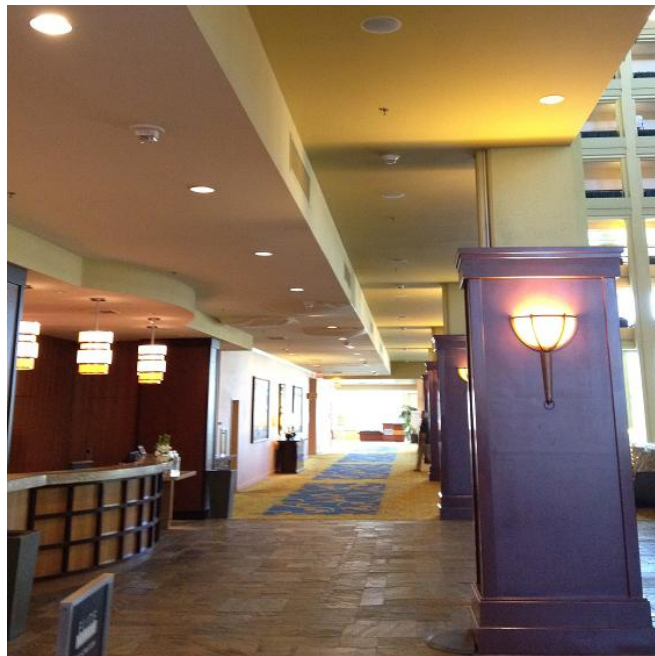
**FIGURE 6. HOTEL #2 LED SCREW-IN**

Thirty-four screw-in RCFLs in a downlight were in Hotel #2's lobby, and six screw-in RCFLs were in the meeting room. The RCFLs in both locations were 15W, 680-lumens. These were replaced with 12W, 600-lumen LED screw-in directional lamps. Figure 6 shows the lobby where the screw-in LEDs were installed.

The readings in the lobby were very close for RCFLs and LEDs. Although surrounding lights could not be turned off, both technologies were tested under the same ambient conditions. In the meeting room, the LED measured very high right below the light due to the 25° beam angle and lower ceiling. Screw-in directional lamps tend to come in narrower beam angles unlike the RCFLs that are available in wider beam angles. The measurement for this site was taken on the floor at various points from right below the lamp to around the lamp.

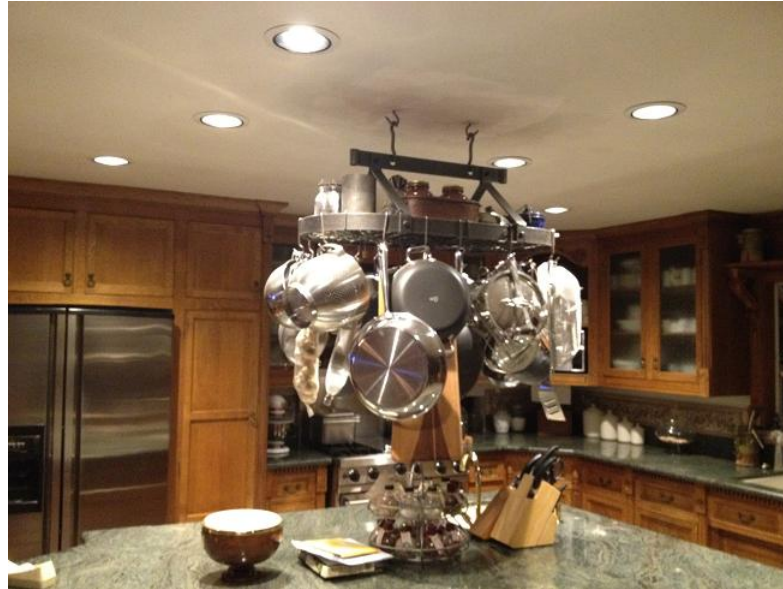
FIGURE 7. RESIDENTIAL CUSTOMER #2 LED RETROFIT

Figure 7 shows the kitchen with eight downlights converted to LEDs. This particular LED downlight came with bezel color options. The existing incandescent downlight trim had a black bezel that was matched for the LED downlight.

Residential Customer #2 had 19 65W incandescent bulged reflector downlights around the house that were replaced with 11W, 600-lumen LED downlights. Due to such a high baseline, the LED downlights provided great energy savings potential for the customer. Similar to Residential Customer #1 results, the results for Customer #2 showed higher FC readings at most measured points. Measurement points were all taken in various planes; kitchen counter in kitchen, floor in the living room, and countertop of the bar.

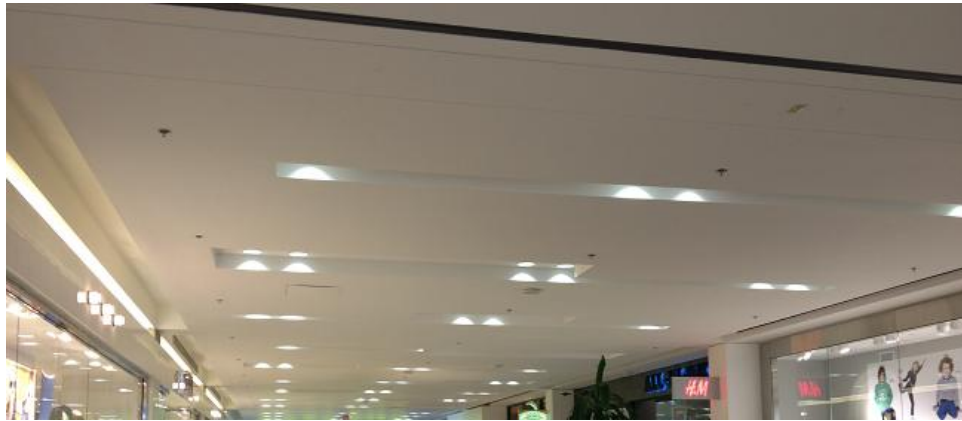
FIGURE 8. MALL LIGHTING

The mall was lit with 48W triple-tube CFLs with 3,200 lamp lumens. According to the photometric data, the existing downlight can with the combination of the CFL only provided 1,468 lumens. The fixture efficiency was less than 50%, which wasted much of the light but was an advantage for LEDs. The LED lumens were measured at the fixture level, which provided absolute lumens coming out of the fixture. A 27W, 1,500-lumen LED downlight was the only fixture available on the Energy Star's qualified list that provided enough light to replace the CFLs.

The existing downlight could not be retrofitted with an LED and no LED retrofit kit was available with the correct specifications. The only option was to purchase a full LED downlight, which had two parts with a light engine and a frame to hold the light engine in place. This was a proprietary kit and enabled the light engine to be replaced separately, leaving the frame and the power supply intact with the ceiling. Although this was a good option, the \$350 price per fixture and the fixture temporarily being off the Energy Star's qualified list during the time of the project stopped this project from moving forward.
