# **All-Electric High-Performance Home: Redding, California Site Monitoring Report**

*Report #: CR19PGE1071*

**Issued:** April 9, 2021

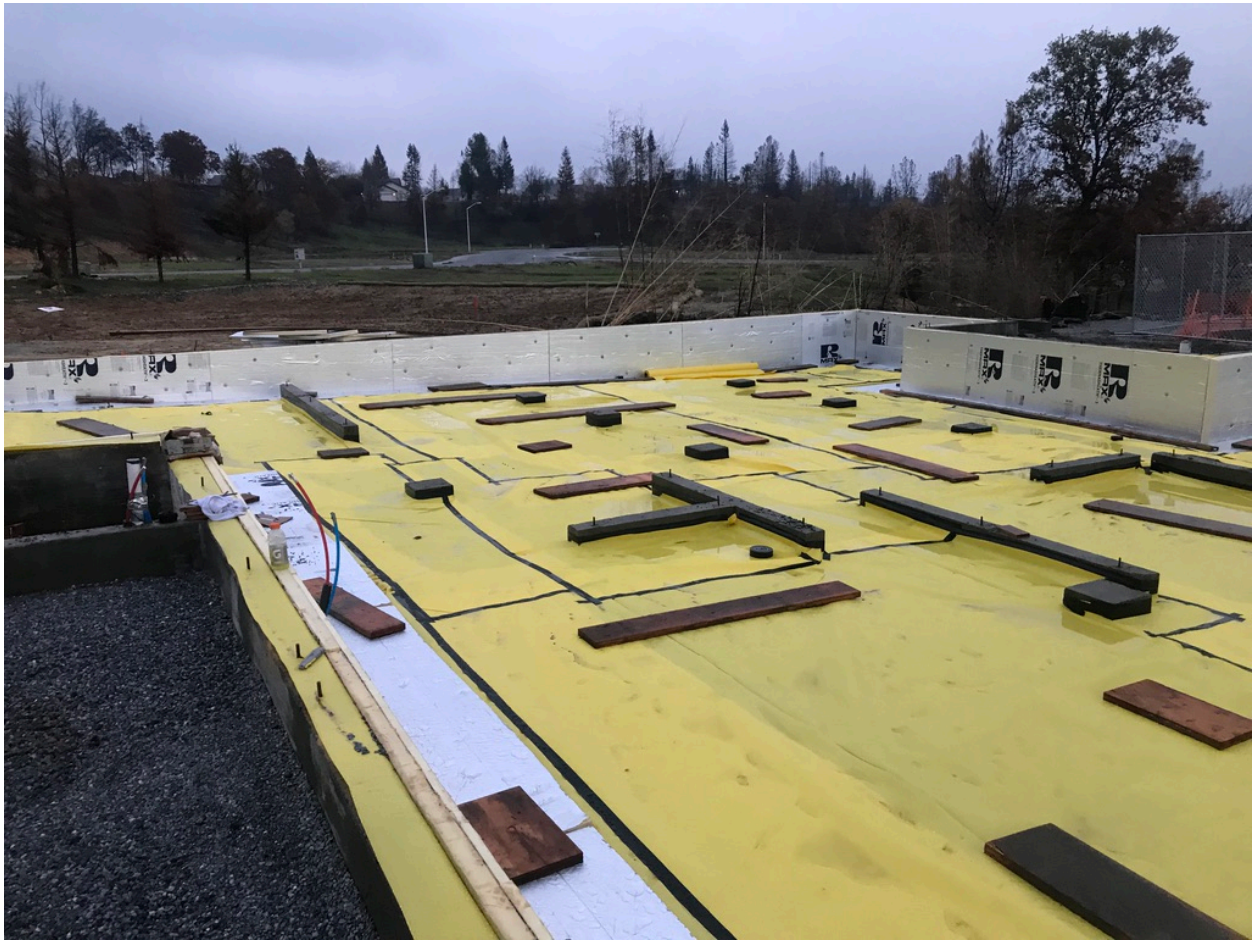
FIGURE 2: CRAWLSPACE PERIMETER INSULATION AND SEALED VAPOR BARRIER

Crawlspace designs are much less common than slab on grade construction in most of California. This is primarily due to cost and ease of construction. Although the Redding1 house used slab on grade, the gradually sloping Redding2 lot combined with a deep hole left from recent wildfire debris removal made a raised foundation a much more affordable option than it would have normally been. Figure 2 shows the indirectly conditioned crawlspace during construction. A subgrade PVC drainage piping system was installed at the low end of the crawlspace before the installation of the 15 mil polyethylene vapor barrier. Three inches (3") of polyisocyanurate foam (R-19) was attached to the interior side of the foundation walls using 12" carriage bolts. Three inches of R-Max (R-19) was also placed directly on top of the vapor barrier around the perimeter of the home in a 2-foot-wide band to meet the Title 24 insulation requirements for a conditioned crawlspace.

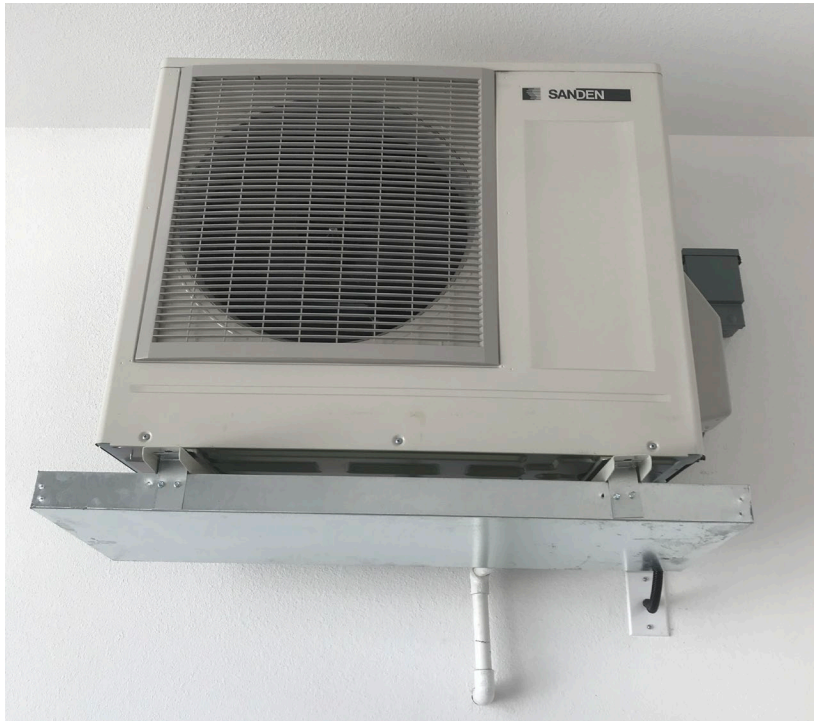
FIGURE 4: SANDEN EVAPORATOR UNIT GARAGE LOCATION

**Water Heating:** Domestic hot water is provided by a Sanden heat pump water heater (HPWH) that utilizes CO<sub>2</sub> as the working refrigerant. The 83-gallon Sanden CO<sub>2</sub> unit (model number GS3-83SSAQA) is rated at a 5.0 COP and 3.84 Energy Factor. Unlike in Redding1, where the outdoor unit was in the back of the house, the Redding2 unit was installed high up in the garage (as shown in Figure 4) to take advantage of warmer inlet air conditions. This location also allows for the cooler exhaust air from the unit to naturally fall downwards, avoiding any possibility of inlet air contamination.<sup>8</sup>
